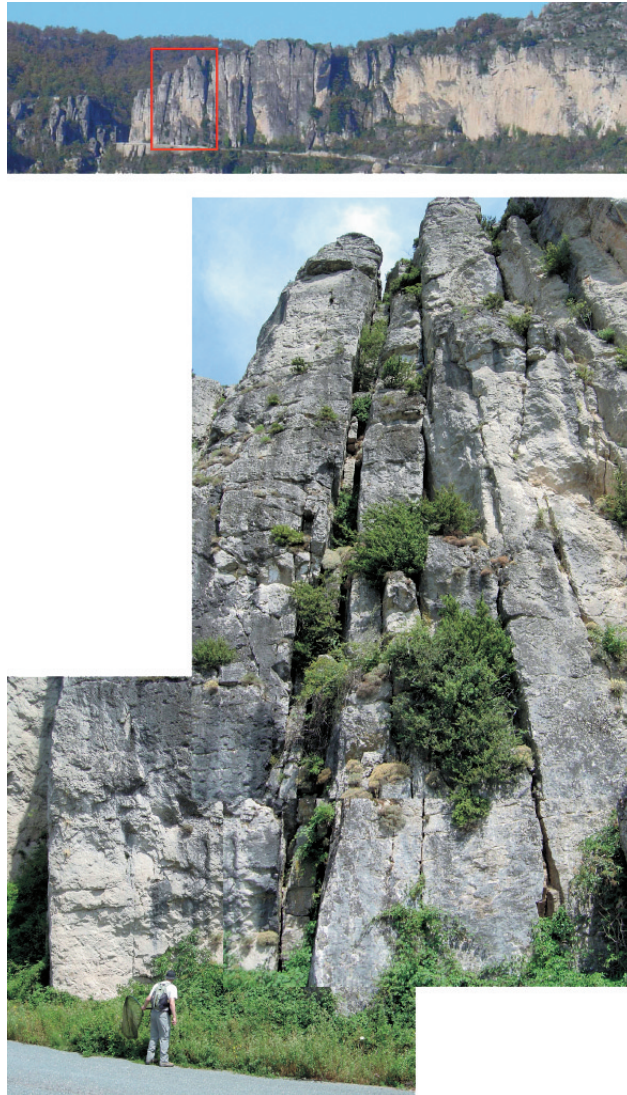
**Figure 2-1.21** Example of fracture swarm (or fracture corridor) affecting the Dogger limestone and dolomite bar at the Pas de l'Escalette (Hérault, France). In this highly characteristic example, vertical fractures sometimes less than one metre apart split a layer several decametres thick, with no vertical displacement whatsoever. These types of swarm can sometimes be followed for several kilometres. If some fractures remain partially open in reservoir conditions, these swarms completely modify the reservoir permeability at kilometric scale
